# New Hampshire Volunteer Lake Assessment Program

## 2002 Bi-Annual Report for Chalk Pond Newbury

NHDES  
Water Division  
Watershed Management Bureau  
6 Hazen Drive  
Concord, NH 03301

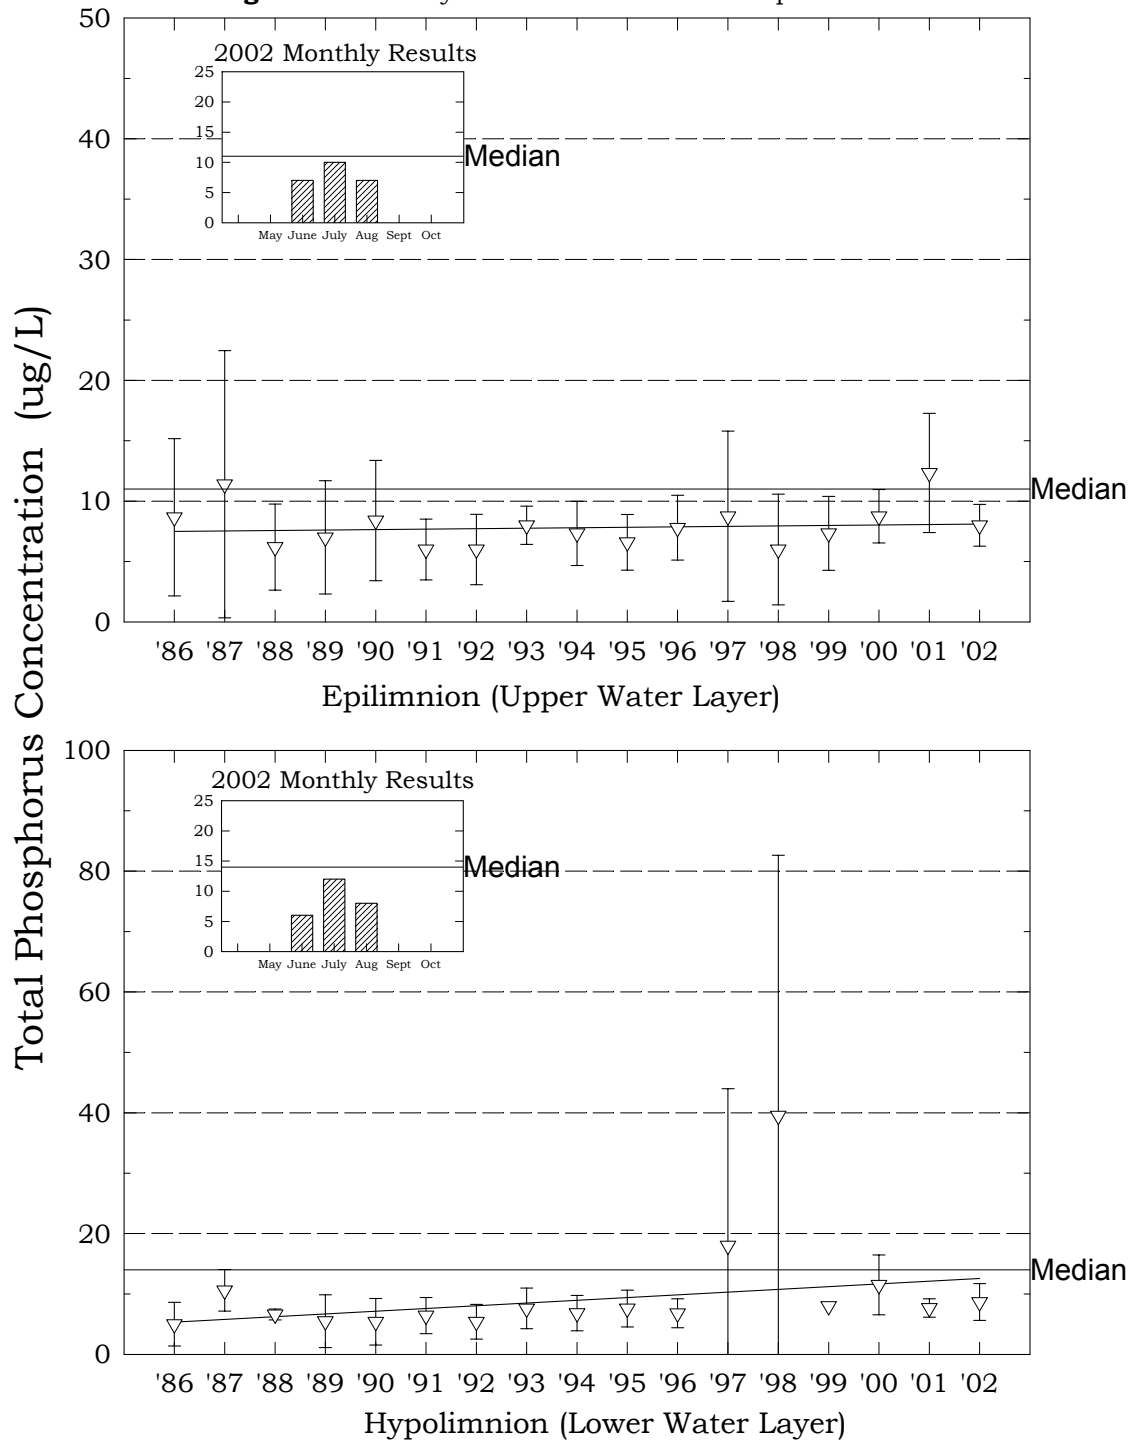
**Figure 3.** Monthly and Historical Total Phosphorus Data.

- **Figure 3 and Table 8:** The graphs in Figure 3 (Appendix A) show the amounts of phosphorus in the epilimnion (the upper layer) and the hypolimnion (the lower layer); the inset graphs show current year data. Table 8 (Appendix B) lists the annual maximum, minimum, and median concentration for each deep spot layer and each tributary since the lake/pond has joined the program.

The current year data for the epilimnion (the top inset graph) and the hypolimnion (the bottom inset graph) show that the total phosphorus concentration **increased** from June to July, and then **decreased slightly** from July to August.

The historical data show that the 2002 mean epilimnetic and hypolimnetic total phosphorus concentration is ***slightly less than*** the state median.

Overall, the statistical analysis of the historical data show that the total phosphorus concentration in the epilimnion (upper layer) and the hypolimnion (lower layer) has ***not significantly changed*** (either *continually increased* or *continually decreased*) since monitoring began in **1986**. Specifically, the total phosphorus concentration in the epilimnion and hypolimnion has remained ***relatively stable*** and has been ***approximately equal to*** the state median. (Note: Please refer to Appendix E for the statistical analysis explanation and data print out.)

One of the most important approaches to reducing phosphorus loading to a waterbody is to continually educate watershed residents about its sources and how excessive amounts can adversely impact the ecology and value of lakes and ponds. Phosphorus sources within a lake or pond's watershed typically include septic systems, animal waste, lawn fertilizer, road and construction erosion, and natural wetlands. If you would like to educate watershed residents about how they can help to reduce phosphorus loading into the lake/pond, please contact the VLAP Coordinator.
